Verdin iMX8M Mini

Errata Document

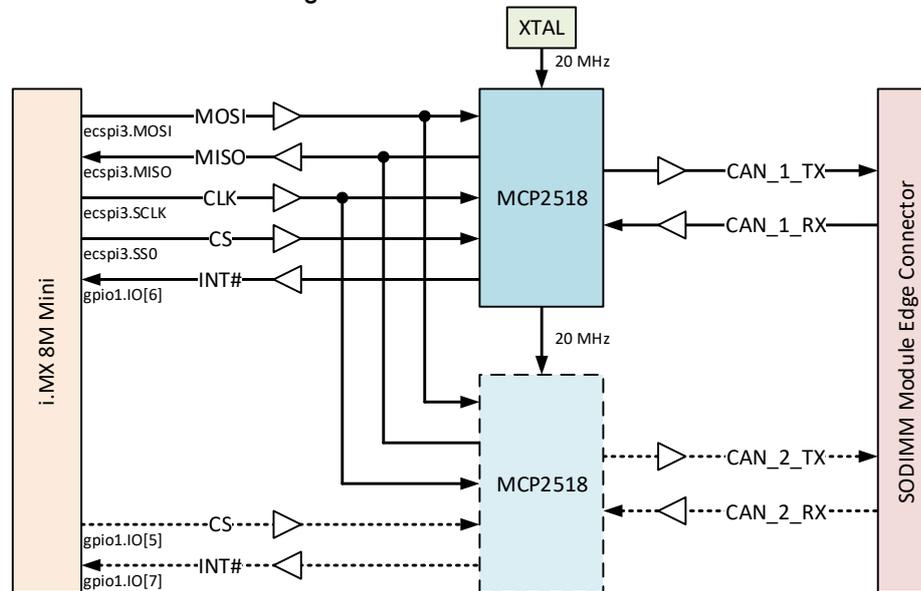
Figure 1: CAN Block Diagram

There are level shifters in the SPI signals between the SoC and the CAN controllers. If none of the CAN controllers are driving the MISO signal (both chip-select signals for the CAN controllers are deactivated), the MSIO signal can get to be floating. This means the MSIO signal is neither driven to GND or 3.3V and could cause an oscillation at the level shifter, which could cause a higher current draw than expected.

There is no software or hardware workaround available for V1.0 modules. A weak external pull-up is added on the modules with version 1.1 to avoid the MISO signal from floating.

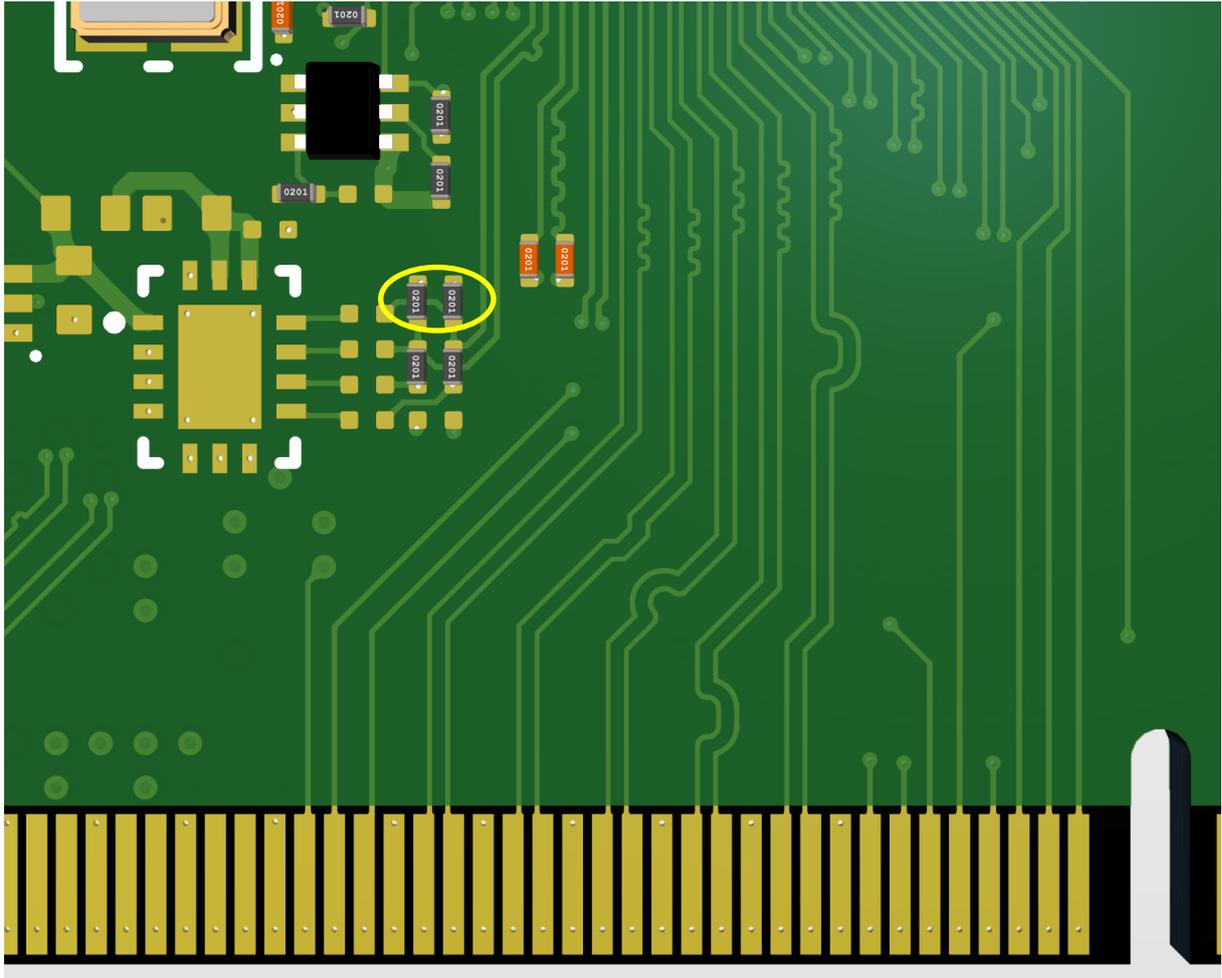
Figure 2: Location of R28 and R29 (Top Side, Top View)

The voltage level of the PCIe reference clock output (PCIE_1_CLK_N and PCIE_1_CLK_P) is too low and not PCIe compliant. For some PCIe peripheral devices, the voltage swing is too small for those devices to operate properly.

The PCIe reference clock available at the module edge connector pins 226 and 228 is generated by the i.MX 8M Mini SoC. The clock signals are unintentionally terminated twice. There are 49.9Ω termination resistors on the module, and the SoC pins have internal terminations as well. This double termination adds too much load on the reference clock, leading to a wrong output level.

Remove the two 49.9Ω termination resistors R28 and R29 on the Verdin iMX8M Mini module. The resistors are located on the top side of the module.
