# Product Change Notification (PCN): 0023 Colibri T30 1GB V1.1G and 0030 Colibri T30 1GB IT V1.1B to versions V1.1X

Date of publication: 25 Apr 2023

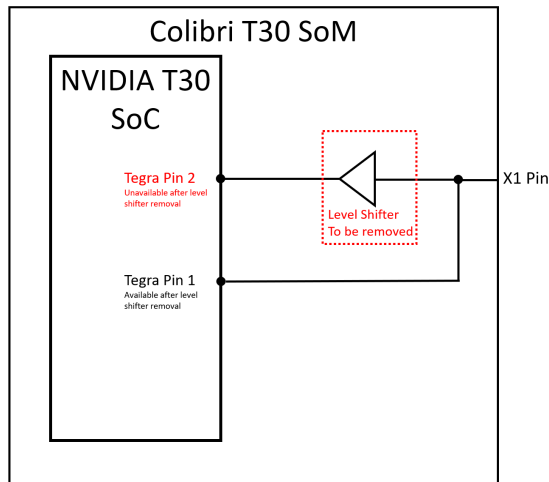
- Removed TI 74AVCA164245ZQLR and related components due to component EOL and shortage

- Parallel camera interface won't be available in V1.1X
- No changes are required on the Colibri carrier board
- SoM Pins affected by this change are : 59, 65, 67, 69, 71, 77, 79, 81, 85, 94, 96, 97, 98, 101, 103  
(see Table 5-18 - Camera Interface Pins in [Colibri T30 datasheet](#))
- All the affected SoM pins multiplexed. They are connected to 2 pins on the SoC-side  
(see Table 4-1 - Colibri Multiplexed Pins in [Colibri T30 datasheet](#))
